Road Building and Landsliding on the Cincinnati Hillsides

Originally published in *The Hillside Trust Outlook*, Winter 2003

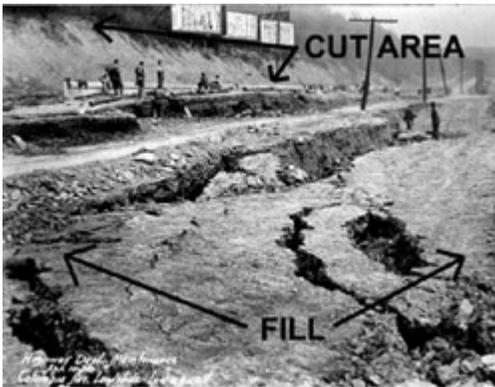
Columbia Avenue in 1930 will soon become Columbia Parkway after it is widened. Photo illustrates early "cut and fill" method of construction in association with a large landslide.

Road building was the first "cut and fill" human activity on the Cincinnati hillsides that can be associated with landsliding. Typical road building efforts involved "cutting" the up slope side of the road bed and "filling" the down slope portion of the road bed with the cut material. The road "cut" over steepened and removed lateral support for the up slope soils and the filling in of the down slope portion of the road unnaturally loaded the hillslope. Cut and fill activity associated with transportation routes have led to numerous landslides with and without engineering input (prior to 1990).

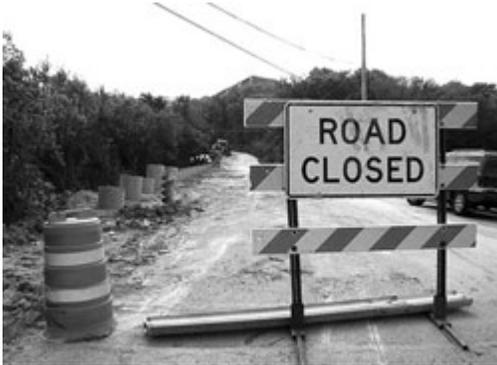
Lehman Road, constructed around the early 1800's, currently being improved along 1700 feet of roadway at a cost of \$1.3 million.

Lehman Road located in Price Hill on the western side of the Mill creek valley may have existed as early as 1805 affording the Lehman family access to their property on the hillside. Prior to 1800, there may have been an access trail near the present day Lehman Road as the first Ohio president, William Henry Harrison, had a hunting lodge above Lehman Avenue. Lehman Road has a history of instability and today is being improved at a cost of 1.3 million dollars with the placement of 199 piers.
